ANDRITZ has recently completed a service at Mayr-Melnhof's FS Karton mill, involving one MG cylinder, two web stabilizers, three dryer cylinders, and a fourth headbox service. From order to completion, it all added up to four service operations in just four months. So – did it all go by the numbers?

Although it started up back in 1990, the 5.25 m wide, 350,000-tonne BM5 at FS Karton in Neuss, Germany, is still one of the largest and most modern recycled boxboard machines in Europe. And every January, the mill makes sure it stays that way - with new improvements.

In January 2017, ANDRITZ carried out a suite of service upgrades on the 350,000-tonne BM5 at Mayr-Melnhof's FS Karton mill in Neuss. Germany, the largest recycled boxboard machine in Europe.

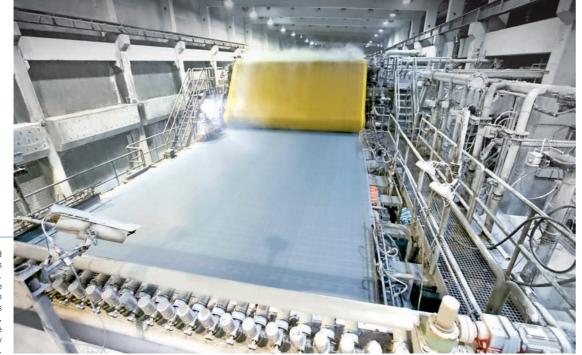
ANDRITZ has now serviced all four headboxes at Neuss during the past five years The most recent upgrade was for the filler ply, which restored the headbox's full technical functionality. enabling it to reach the desired process and quality parameters

BM5 uses four fourdrinier formers to make its boxboard - first top layer, second top layer, filler layer, and back layer. ANDRITZ recently revised the headboxes for three of the four formers and completed the full set this January, bringing the headbox for the filler ply back up to date. Johannes Kraxner, Service Manager, ANDRITZ Tissue, Paper & Board Machines, notes that the headbox had already far outlasted its design expectations, "For example, you would normally change the diffusor inserts every 8-10 years, but these had lasted 16 years!"

As part of a full headbox service, ANDRITZ installed new bottom and top slice lip and renewed all seals. "We took it completely apart," Kraxner explains, "which has given us benefits such as improved cross-direction and machine-direction basis-weight control and correct sealing on the mixing chamber right from the start-up. The upgrade has restored full technical functionality to the headbox, enabling it to reach the desired process and quality parameters."
